FAILURE OF A LOW RAIL IN A CURVED RAILWAY TRACK SUBJECT TO LONG TERM RAIL-WHEEL INTERACTIVE WEAR

ABSTRACT

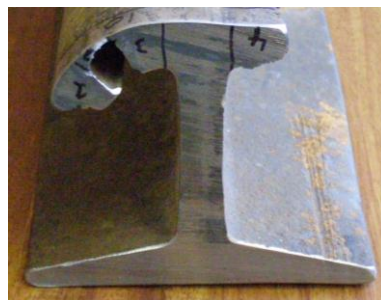
It can be seen from the rail sample shown in Figure 1 that the rail experienced severely worn on the railhead with a large amount of lateral plastic deformations and material loss.

Figure 1. A cross sectional view of the rail sample

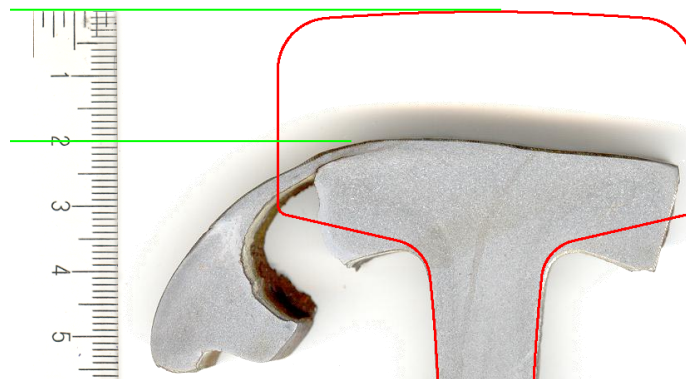
The deformed rail profile was compared with the undeformed rail sections as shown in Figure 2. The red line in Figure 2 shows the profile of a 80lb ASCE rail manufactured by HarmerSteel (2009). About 20mm thick rail material had been lost from the railhead due to plastic deformation and wear. The plastic flow was accompanied by a crack that caused the separation of a part of rail from the railhead. The crack appeared to be initialized in the horizontal direction in a location below the rail surface. It seemed that a part of the railhead was pushed away by a shear force generated by the plastic flow on the railhead. The geometrical profiles on both sides of the crack had similar profiles. A mushrooming shaped plastic deformation happened at the end of the railhead. The mushrooming type of deformation was regarded as a common type of rail degradation (Reddy et al. 2008).

Figure 2. Comparison between the deformed rail head and an undeformed rail

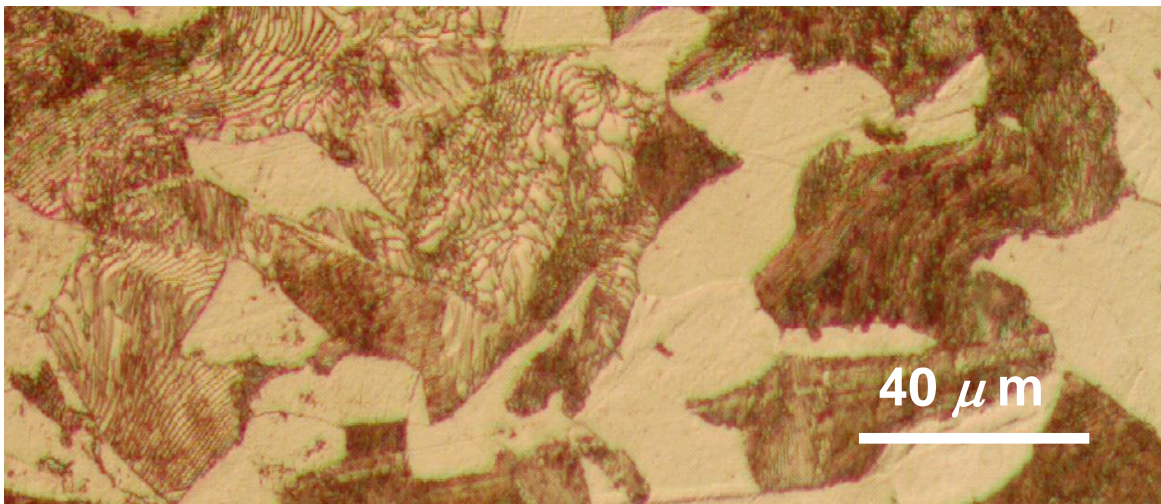
An Olympus BX40F4 optical microscope with 500x magnification was used for microscopy examination of the rail samples. Optical images were taken from samples at different locations with an increasing depths from the surface of the railhead. Figure 3 shows an image taken at 5mm below the rail surface. It can be seen from Figure 3 that clear pearlitic lamella microstructure is surround by proeutectoid ferrite. By contrast, severe plastic flow was observed near the railhead within about 2mm from the railhead surface. Grains in this region were severely distorted due to plastic flow in the lateral direction as shown in Figure 4 that was taken at a depth of 80 μm into the railhead. It can be seen that both proeutectoid ferrite and pearlite are severely deformed with grains being layered and reoriented along the lateral direction. The grains below the main crack are less deformed than the grains above the crack.

Figure 3. Pearlitic lamella structure with ferrite (light phase) and cementite (dark phase)

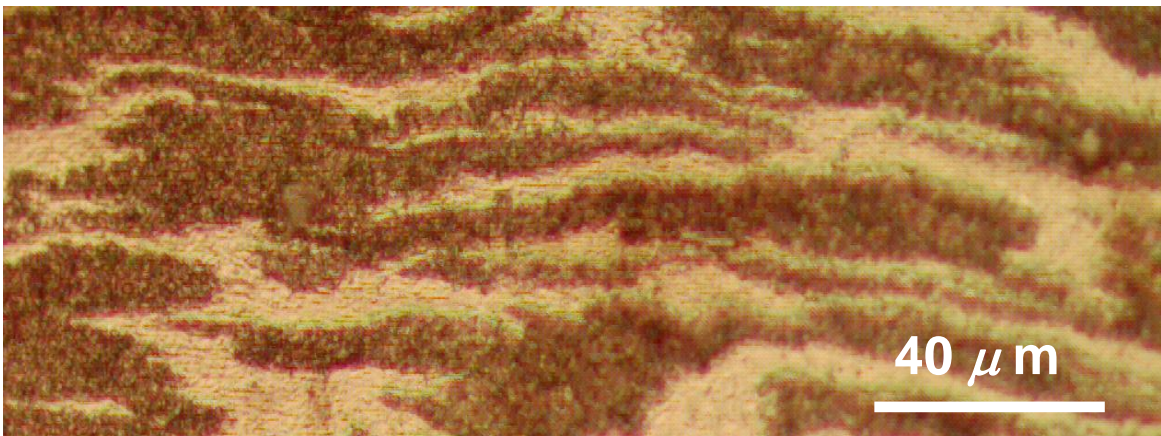
Figure 4. Heavily deformed proeutectoid ferrite and distorted pearlite structure (80 μm from the surface of the railhead)

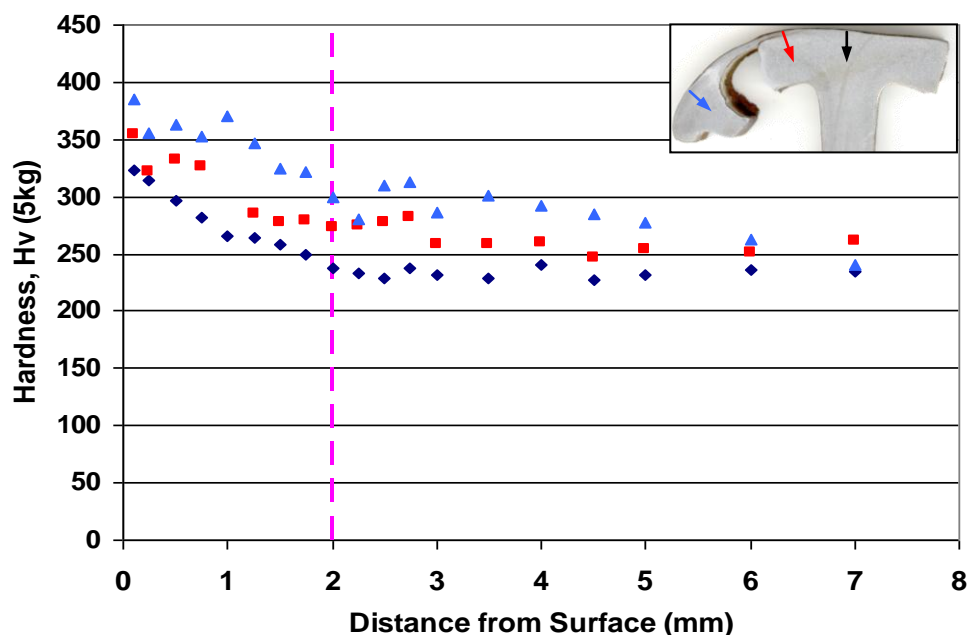
Figure 5. Hardness test results

Vickers hardness tests were conducted on the rail sample from the centre to the side and from the surface to the inside of the railhead in accordance with AS1817.1 (2003). The HV hardness results are shown in Figure 5. A test force of 5kg was applied and hold for 10 second. The average diagonal length of indentations was 182 μm . It can be seen that the hardness was higher near the rail surface with HV values ranging from 320 to 385 due to the strain hardening. Variations in hardness measurements in certain locations were recorded, which may be due to the difference of hardness in ferrite and pearlite grains. It was found that the depth of strain hardened layers was about 2 mm, in which the hardness was decreased to the bulk material hardness (Average 261HV).
